BRIDGE REHABILITATION WITH STRUCTURAL LIGHTWEIGHT CONCRETE

WHITEHURST FREEWAY, WASHINGTON, DC

Bridge Rehabilitation Permits Higher Live Loads

By Dennis W. Stollendorf, PE⁽¹⁾ and Thomas A. Holm, PE⁽²⁾

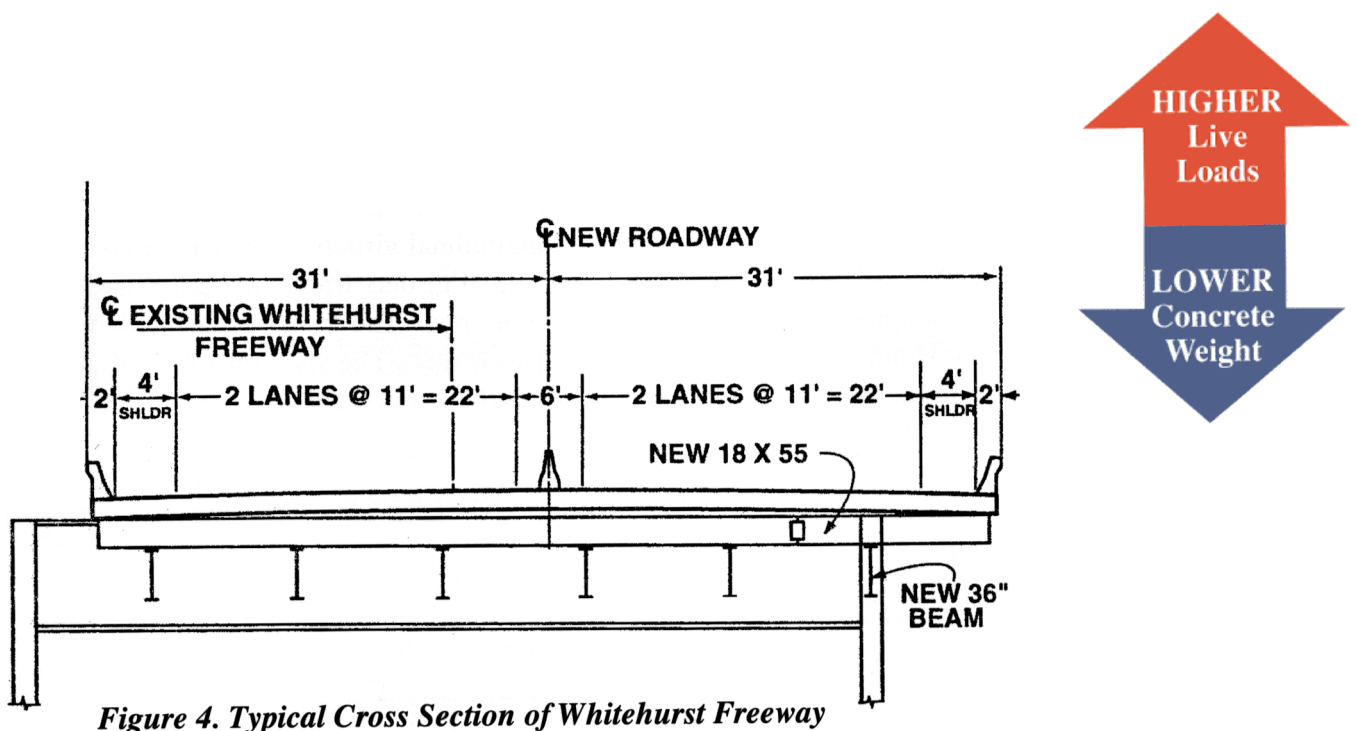
Figure 4. Typical Cross Section of Whitehurst Freeway

Requirements of the rehabilitation of the Whitehurst Freeway superstructure called for widening by approximately 2.44 m (8 ft.) through most of its length. Because of the constraints on the canal side of the structure (several buildings were within .5 m (2 ft.) of the existing parapet), the structure was widened toward the Potomac River side. A typical cross-section is shown in Fig. 4. The original bridge deck was a 191 mm (7.5 in.) thick slab with a 50 mm (2 in.) asphalt overlay. The structure was originally designed to carry H20 truck loads.

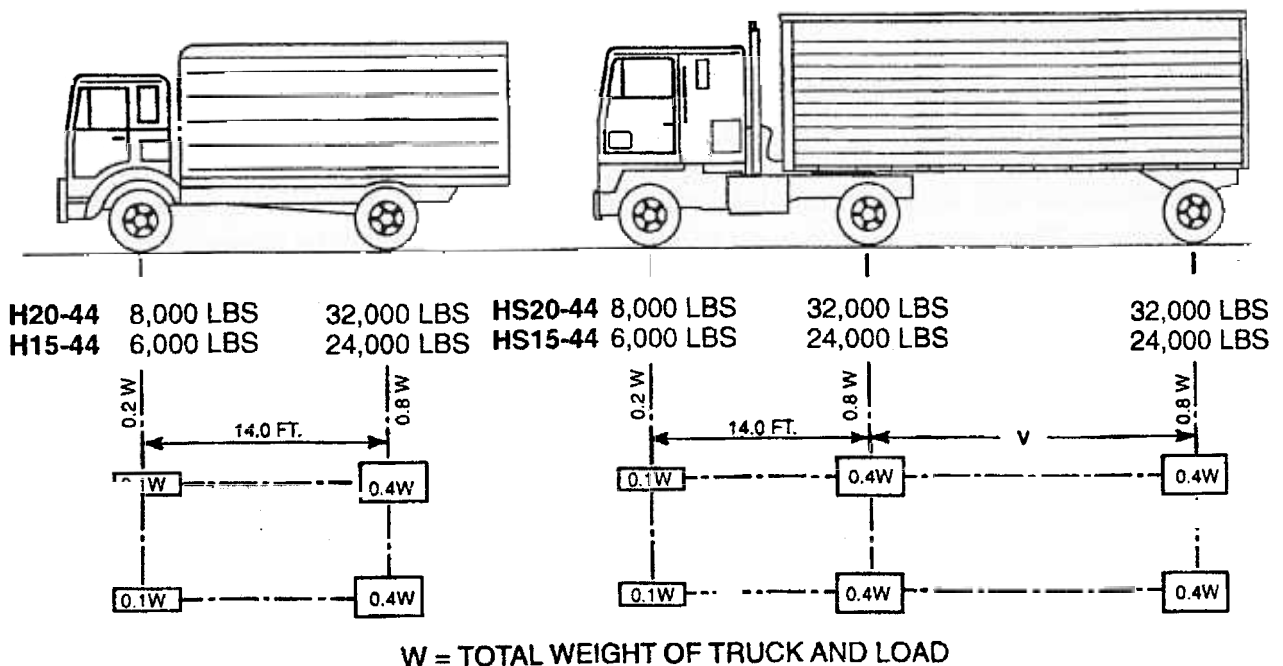
Figure 5. AASHTO H20-44 and HS20-44 Loadings

The Washington, DC Department of Public Works and the Federal Highway Administration decided that in order to eliminate the past practice of having large trucks exit into the Georgetown streets, the new replacement elevated structure should be upgraded to H20-S16 truck loading (Fig.5). The Whitehurst Freeway elevated structure consists of longitudinally reinforced slabs with stringers placed transversely. The stringers are supported on longitudinal girders spaced at a maximum of 5.95 m (19 ft. 6 in.) on center. The longitudinal girders frame into cross-girders which are supported at their ends on steel columns. The span between columns varies, but is normally 18 m (59 ft.) center to center. The span for longitudinal girders is from 12.2 to 22.9 m (40 to 75 ft.) with the majority in the range of 13.7 to

in) overlay. However, difficulties arose in applying the increase in live loading to the existing longitudinal and cross-girders. A 40% increase in live load occurs in a 15.3 m (50 ft) span when upgrading from H20 to HS20.

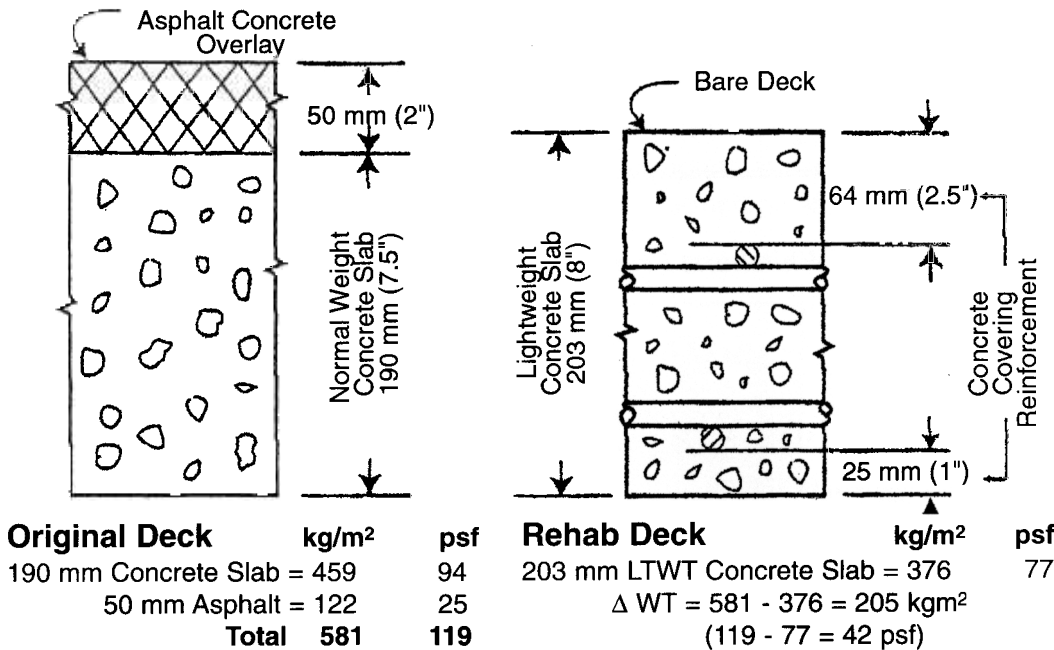
Figure 6. Original and Rehabilitated Decks for Whitehurst Freeway

The only practical way to allow rehabilitation of the existing structure was to use structural lightweight concrete. The use of lightweight concrete allowed the new deck to be placed with a net savings of 205 kg/m² (42 psf), more than one-third of the original deck weight. Fig. 6 shows a comparison of slab weights between the original and rehabilitated structure. This reduction in self weight greatly offset the increase in loading due to both additional bridge width as well as the increased live load requirements. The transverse stringers remained adequate except on the river side where the widening necessitated greater cantilever dimensions. Of 180 existing longitudinal girders, only 42 required strengthening. Overload of the existing structural members was low enough to allow the strengthening repair to be accomplished by adding flange plates bolted to the existing wide flange beams. The strengthening was completed while the deck was removed. The plates were attached using high strength bolts (Fig 7). The existing girders were analyzed in their partially unloaded condition with a live load restriction of H10 on the half of the structure remaining in service. Plates were added to the bottom of the top and bottom flange to eliminate the need for disturbing the transverse stringers. New plates were added to

Initial studies were directed at increasing the rated load capacity using regular weight concrete while strengthening the existing structure. A new 203 mm (8 in) ordinary concrete deck would have weighed less than the original 191 mm (7.5 in) concrete plus 50 mm (2

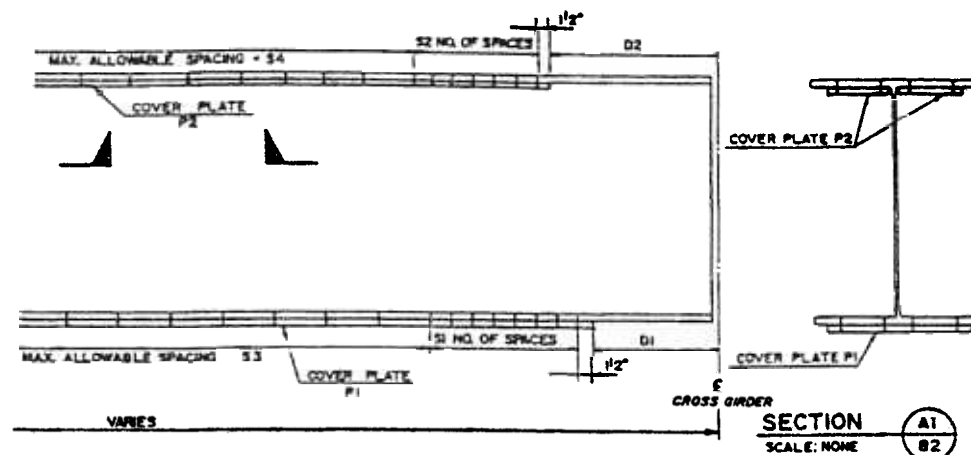
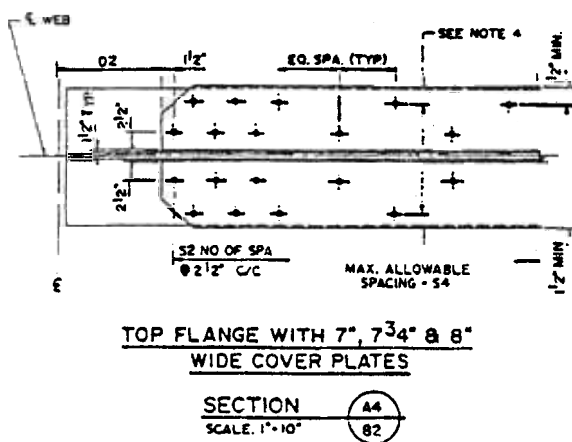
Figure 7. Rehabilitation of Existing Longitudinal Girders

STRENGTHENED LONGITUDINAL GIRDER TYPE A - ELEVATION
SCALE: NONE

ALL BOLTS ARE 7/8" DIAMETER HIGH STRENGTH (H.S.) BOLTS.
 BOTTOM FLANGE BOLT PATTERNS TO MATCH EXISTING RIVET PATTERNS IN AREAS OF INTERSECTION BETWEEN CROSS BRACING AND LONGITUDINAL GIRDERS.
 EDGE DISTANCE TO OUTSIDE OF FLANGE TO COINCIDE WITH EXISTING CROSS BEAM RIVET EDGE DISTANCE. IN AREA OF CROSS BEAMS, USE EXISTING CROSS BEAM RIVET PATTERN INSTEAD OF PATTERN SHOWN.

ing plates as necessary) placed directly adjacent to the existing flange angles and attached with high strength bolts. The work was completed in carefully monitored stages to maintain the integrity of the existing girders. Transverse stiffeners were maintained on one side of the web at all times. The main reinforcing angles were attached to the web on one side first after removing the stiffener angle on that side only. The new reinforcing angle was not bolted to the web.

A temporary stiffener angle was attached between the existing flange angle and stiffener stub previously cut to permit erection of the new reinforcing angle. The stiffener on the opposite side of the web was then removed, the reinforcing angle erected and the holes drilled through the web, and the H.S. bolts installed (Fig 8.). The superstructure was strengthened while 2 lanes of traffic out of the original 4 were maintained at all times. The traffic was made directional with the traffic flow reversing from inbound in the morning to outbound in the evening.

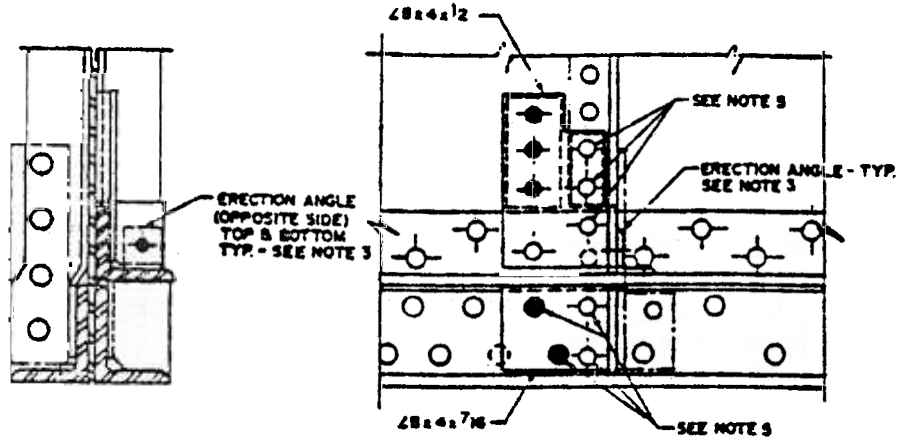
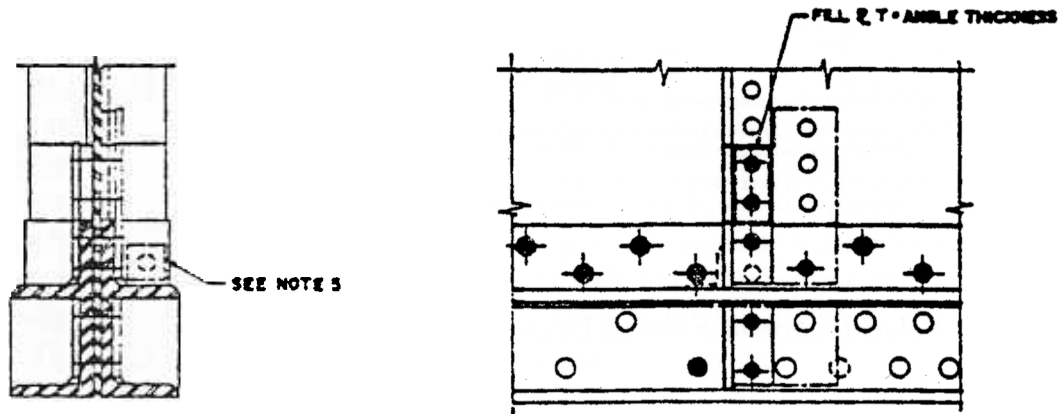
Figure 8. Cross-girder Strengthening

RECOMMENDED SEQUENCE - STAGE 2:

1. Remove rivet head on stiffeners as shown.
2. Remove rivet heads and drill out rivets on flange angle as shown.
3. Erect new flange angles on stiffener removal side only. Use erection angle and bolts shown to attach $8 \times 4 \times \frac{1}{2}$ angle to flange angle. Fill plates can be tack welded to $4 \times 8 \times \frac{7}{16}$ angle.
4. Erect $4 \times 8 \times \frac{7}{16}$ angles between new and old flange angles.
5. Holes in new angles and fill plates to match existing stiffener holes.
6. Drill holes indicated and install H.S. bolts.

SECTION C
SCALE: 1/2" = 1'-0"

STAGE 2

DETAIL C
SCALE: 1/2" = 1'-0"

SECTION D
SCALE: 1/2" = 1'-0"

STAGE 4 - FINAL

DETAIL D
SCALE: 1/2" = 1'-0"

Of the total 76 cross-girders in the structure, only 32 required strengthening. Use of structural lightweight concrete made it possible to keep overload of the existing cross-girder to a minimum and allowed the strengthening to be completed with using temporary supports to reduce the dead load moments on the girders. The cross-girders are riveted girders with 2.29 m (90 in) deep webs and various sizes of angles and plates acting as flanges. The strengthening consisted of angles (includ-
