# Final Statement of Basis

Norlite Corporation  
Cohoes, Albany County  
EPA ID No. NYD 080469935  
Site No. 401041

# FINAL STATEMENT OF BASIS

Norlite Facility  
Cohoes, Albany County  
NYD080469935/ Site No.401041

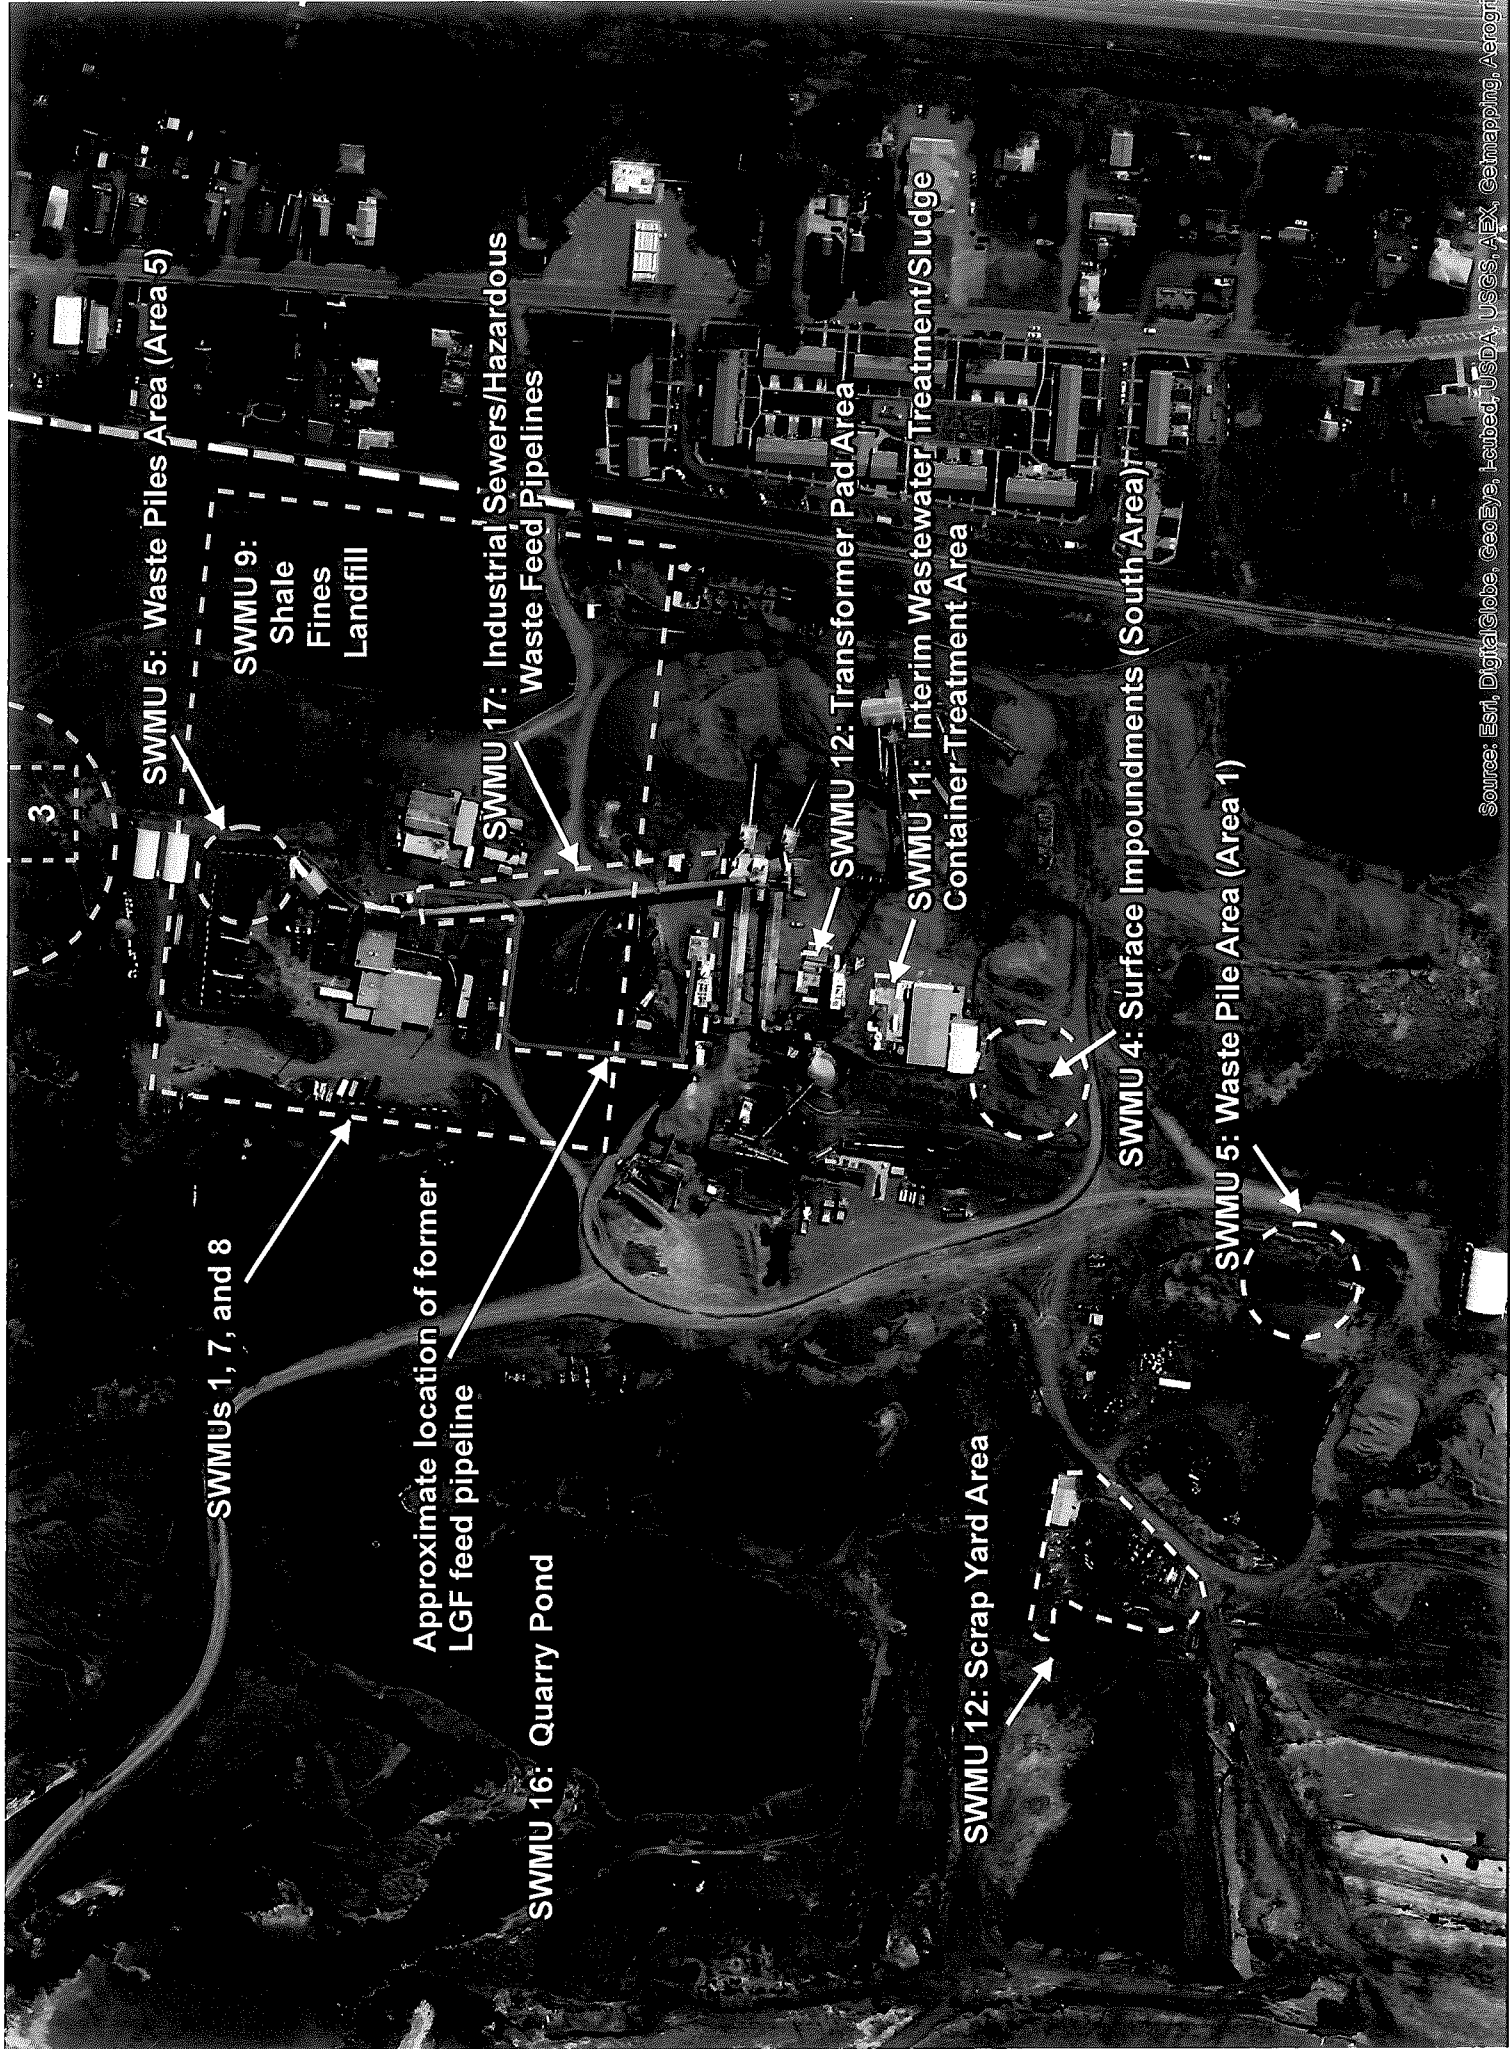
SWMU 5: Waste Piles Area (Area 5)

SWMU 9:  
Shale  
Fines  
Landfill

SWMU 17: Industrial Sewers/Hazardous  
Waste Feed Pipelines

SWMU 16: Quarry Pond

SWMU 12: Scrap Yard Area

A site location map is attached as Figure 1 and a facility map is attached as Figure 2.

In March 1993, Norlite began using a new Tank Farm facility that included the current aboveground fuel pipeline. Prior to this, fuel was supplied to the kilns via underground pipelines. Based on records reviewed during the RFI workplan development, there were three buried fuel lines and a vent line, presumed to be three inch diameter stainless steel. No surveyed drawings or plans showing the exact location and depth of the underground feed lines are available, but the approximate location of the former underground feed lines is shown on Figure 2.

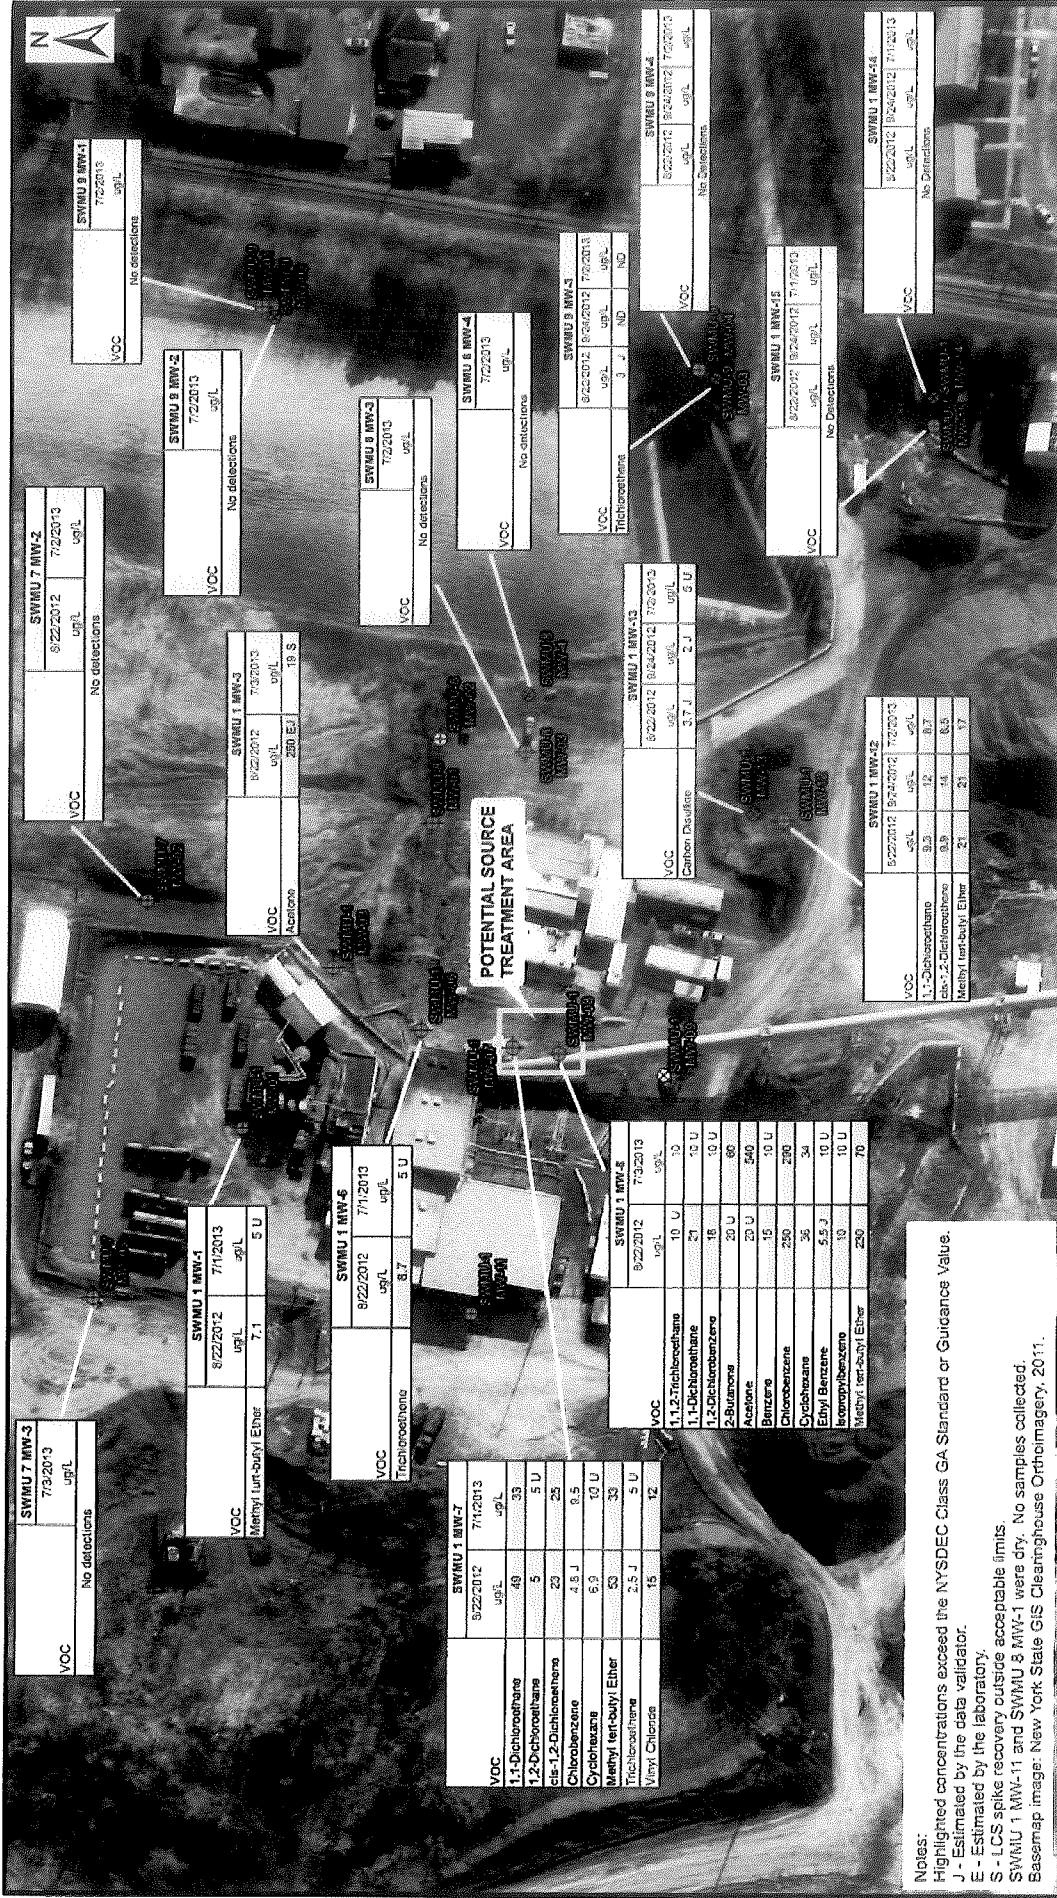
SWMU 7 MW-3	
VOC	7/3/2013
No detections

SWMU 7 MW-2	
VOC	9/22/2012
No detections
